Paradoxical undersensing due to quiet timer blanking

A case of undersensing of atrial activity by a dual chamber pacemaker is presented. Programming to more sensitive voltages exacerbated undersensing, and programming to less sensitive levels resolved the undersensing. The mechanism by which pacemaker sense amplifiers function to create apparent paradoxical undersensing is reviewed.

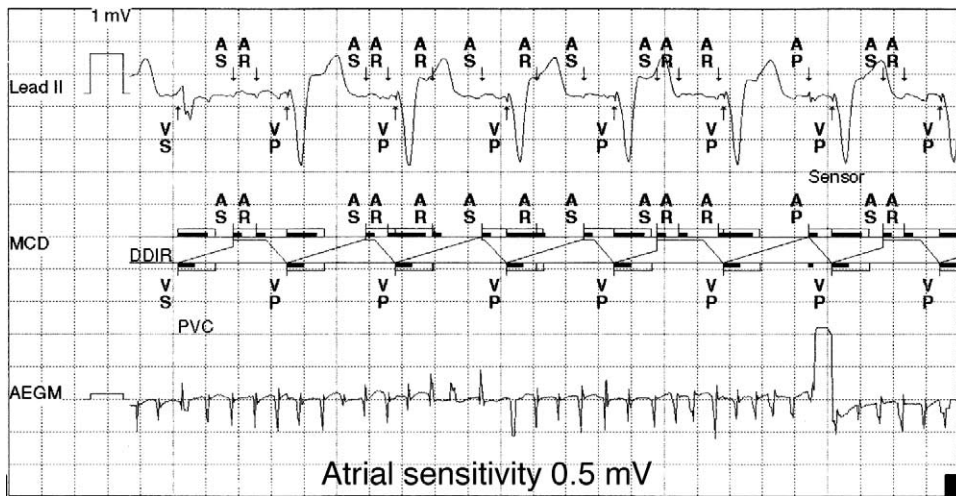
monitor; the atrial sensitivity was set at .5 mV bipolar (Figure 1). Atrial sensitivity was set to .35 mV; undersensing was exacerbated and the frequency of atrial pacing increased (Figure 2). Entering and exiting mode switch did not affect this behavior. With atrial sensitivity at .25 mV, there was total loss of atrial sensing and failure to mode switch (not shown). Atrial sensitivity was programmed to 1.0 mV and nearly complete atrial sensing was noted (Figure 3). P wave amplitudes measured 4.0 to 5.6 mV during the atrial arrhythmia.

In the present case, very large amplitude flutter waves likely caused repeated initiation of quiet timer blanking intervals, resulting in failure to sense atrial events during such intervals. With a decrease in atrial sensitivity, the difference between the programmed sensitivity and flutter wave amplitude was diminished. This resulted in less “ringing” in the sense amplifier and quiet timer blanking. Paradoxically, with decreased programmed sensitivity detection of atrial events, improved and appropriate mode switching occurred.

Figure 1 Surface lead II, markers channel diagrams (MCD), and intracardiac atrial electrograms with atrial sensitivity at .5 mV. Black bars in marker channel diagram indicate blanking periods; open bars indicate refractory periods. Mode switch has occurred to DDIR but there is undersensing of the atrial events as indicated by an atrial paced (AP) event at the sensor rate in the right side of the figure. AS = atrial sensed event; AP = atrial paced event; AR = atrial refractory sensed event; VP = ventricular paced event; AEGM = atrial intracardiac electrogram.

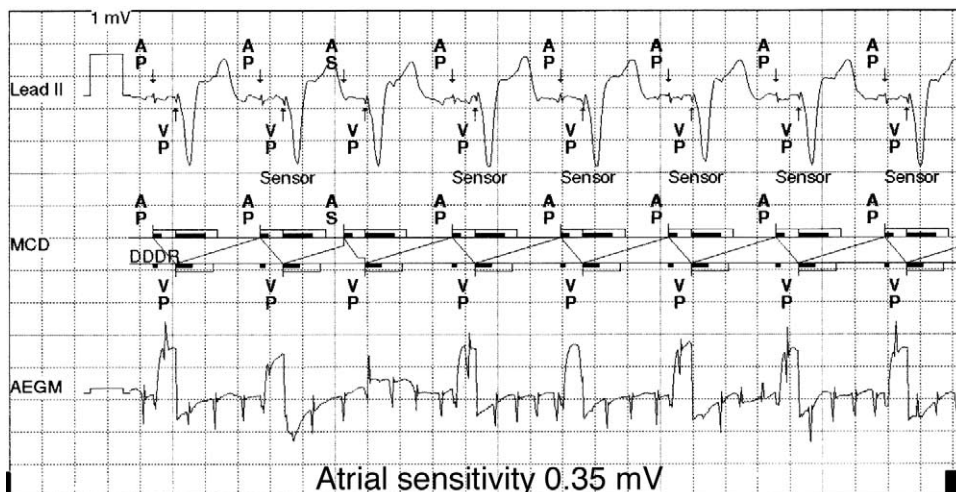
Figure 2 Arrangement of tracings is the same as in Figure 1. Atrial sensitivity is now programmed to .35 mV. Mode switch has not occurred and the device remains DDIR and AV paces at the sensor indicated rate. There is nearly complete failure to sense atrial events and dual-chamber pacing at the sensor rate is seen. Abbreviations as in Figure 1.

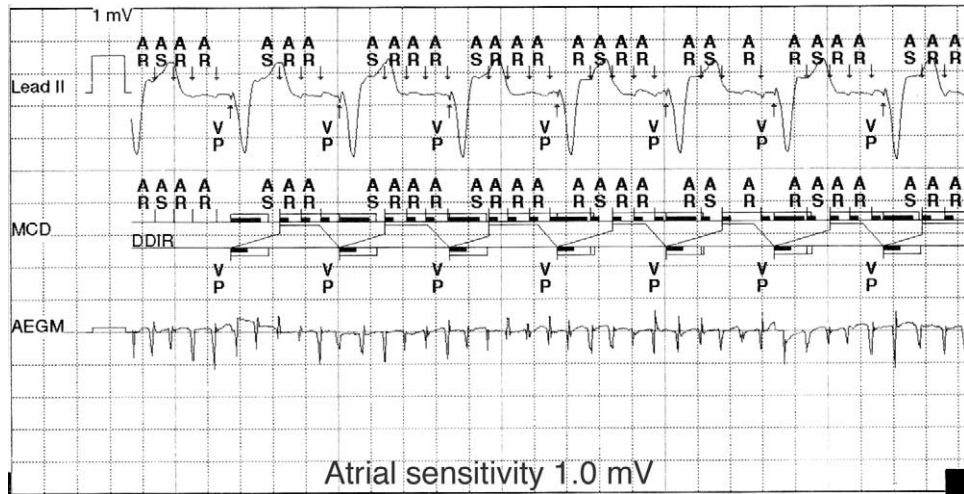
Figure 3 Arrangement of tracings is the same as in Figures 1 and 2. Atrial sensitivity is now programmed to 1.0 mV. The device has mode switched to DDIR and there is nearly complete sensing of atrial events that fall outside the postventricular atrial blanking period. Abbreviations as in Figure 1.

This case report demonstrates an uncommon cause of undersensing that is correctable with a nonintuitive maneuver, ie, programming to less sensitive voltage levels. This represents normal pacemaker sense amplifier function for many pulse generators. In the present case, failure of appropriate mode switching was the clinical outcome. This phenomenon may, however, assume greater importance as atrial antitachycardia devices gain wider use.
